GEOLOGIC HAZARDS AND LAND-USE PLANNING FOR TOOELE VALLEY AND THE WEST DESERT HAZARDOUS INDUSTRY AREA, TOOELE COUNTY, UTAH

Barry J. Solomon and Bill D. Black, editors

OPEN-FILE REPORT 318
UTAH GEOLOGICAL SURVEY
a division of
UTAH DEPARTMENT OF NATURAL RESOURCES

October 1995

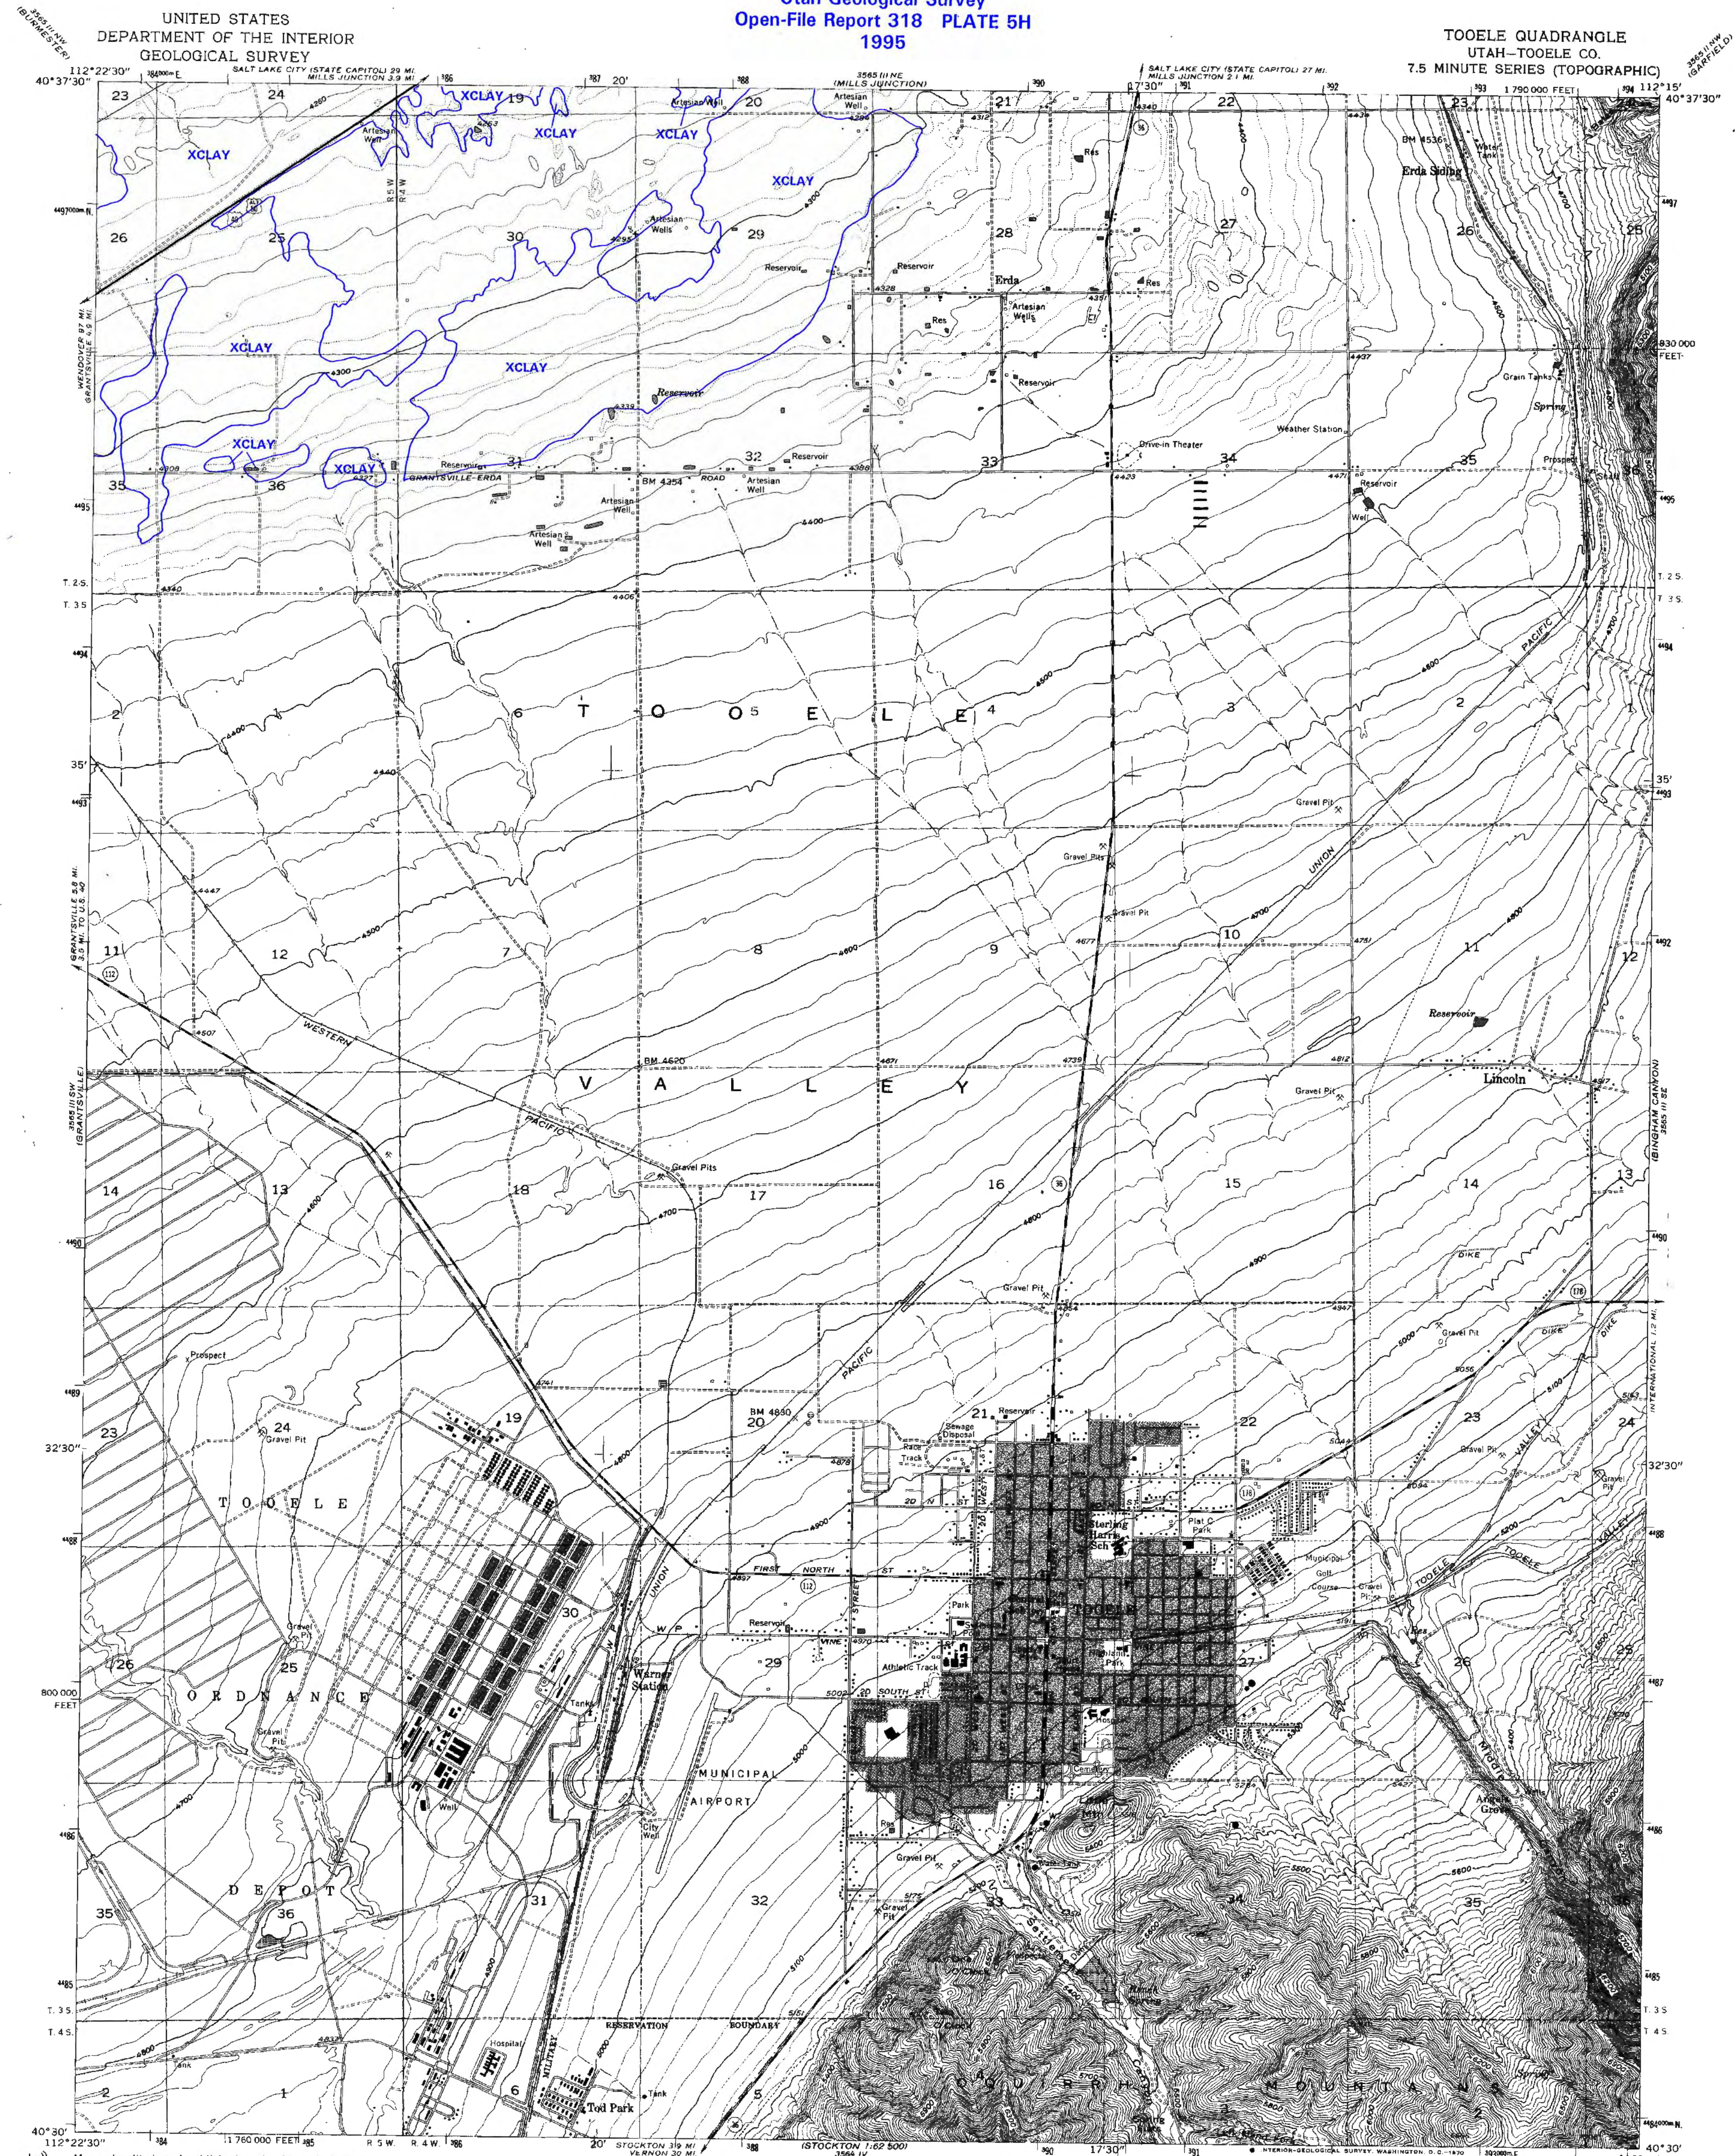
COMPILED BY BILL D. BLACK
DRAFTED BY NOAH P. SNYDER
Utah Geological Survey
Open-File Report 318 PLATE 5H
1995

Problem soils, Tooele quadrangle, Tooele County, Utah.

XCLAY Possible expansive soil.
GYP Possible gypsiferous soil.
GYP/XCLAY Both possible gypsiferous and expansive soils.

Note: A standard soil investigation is recommended in all areas, including those
where expansive and gypsiferous soils are not present (see table 1).

Plate 5 shows the likely extent of expansive and gypsiferous soils, based on surficial geology, in the WDHIA and Tooele Valley (figure L-5). The map is designed to highlight areas where these soils may be present and should be evaluated in standard soil-foundation investigations prior to development. In hazard areas, improperly designed roads and structures can be susceptible to damage. The maps are generalized and other localized areas may occur outside of mapped problem-soil areas. Areas where piping or mine subsidence may be found were not mapped.

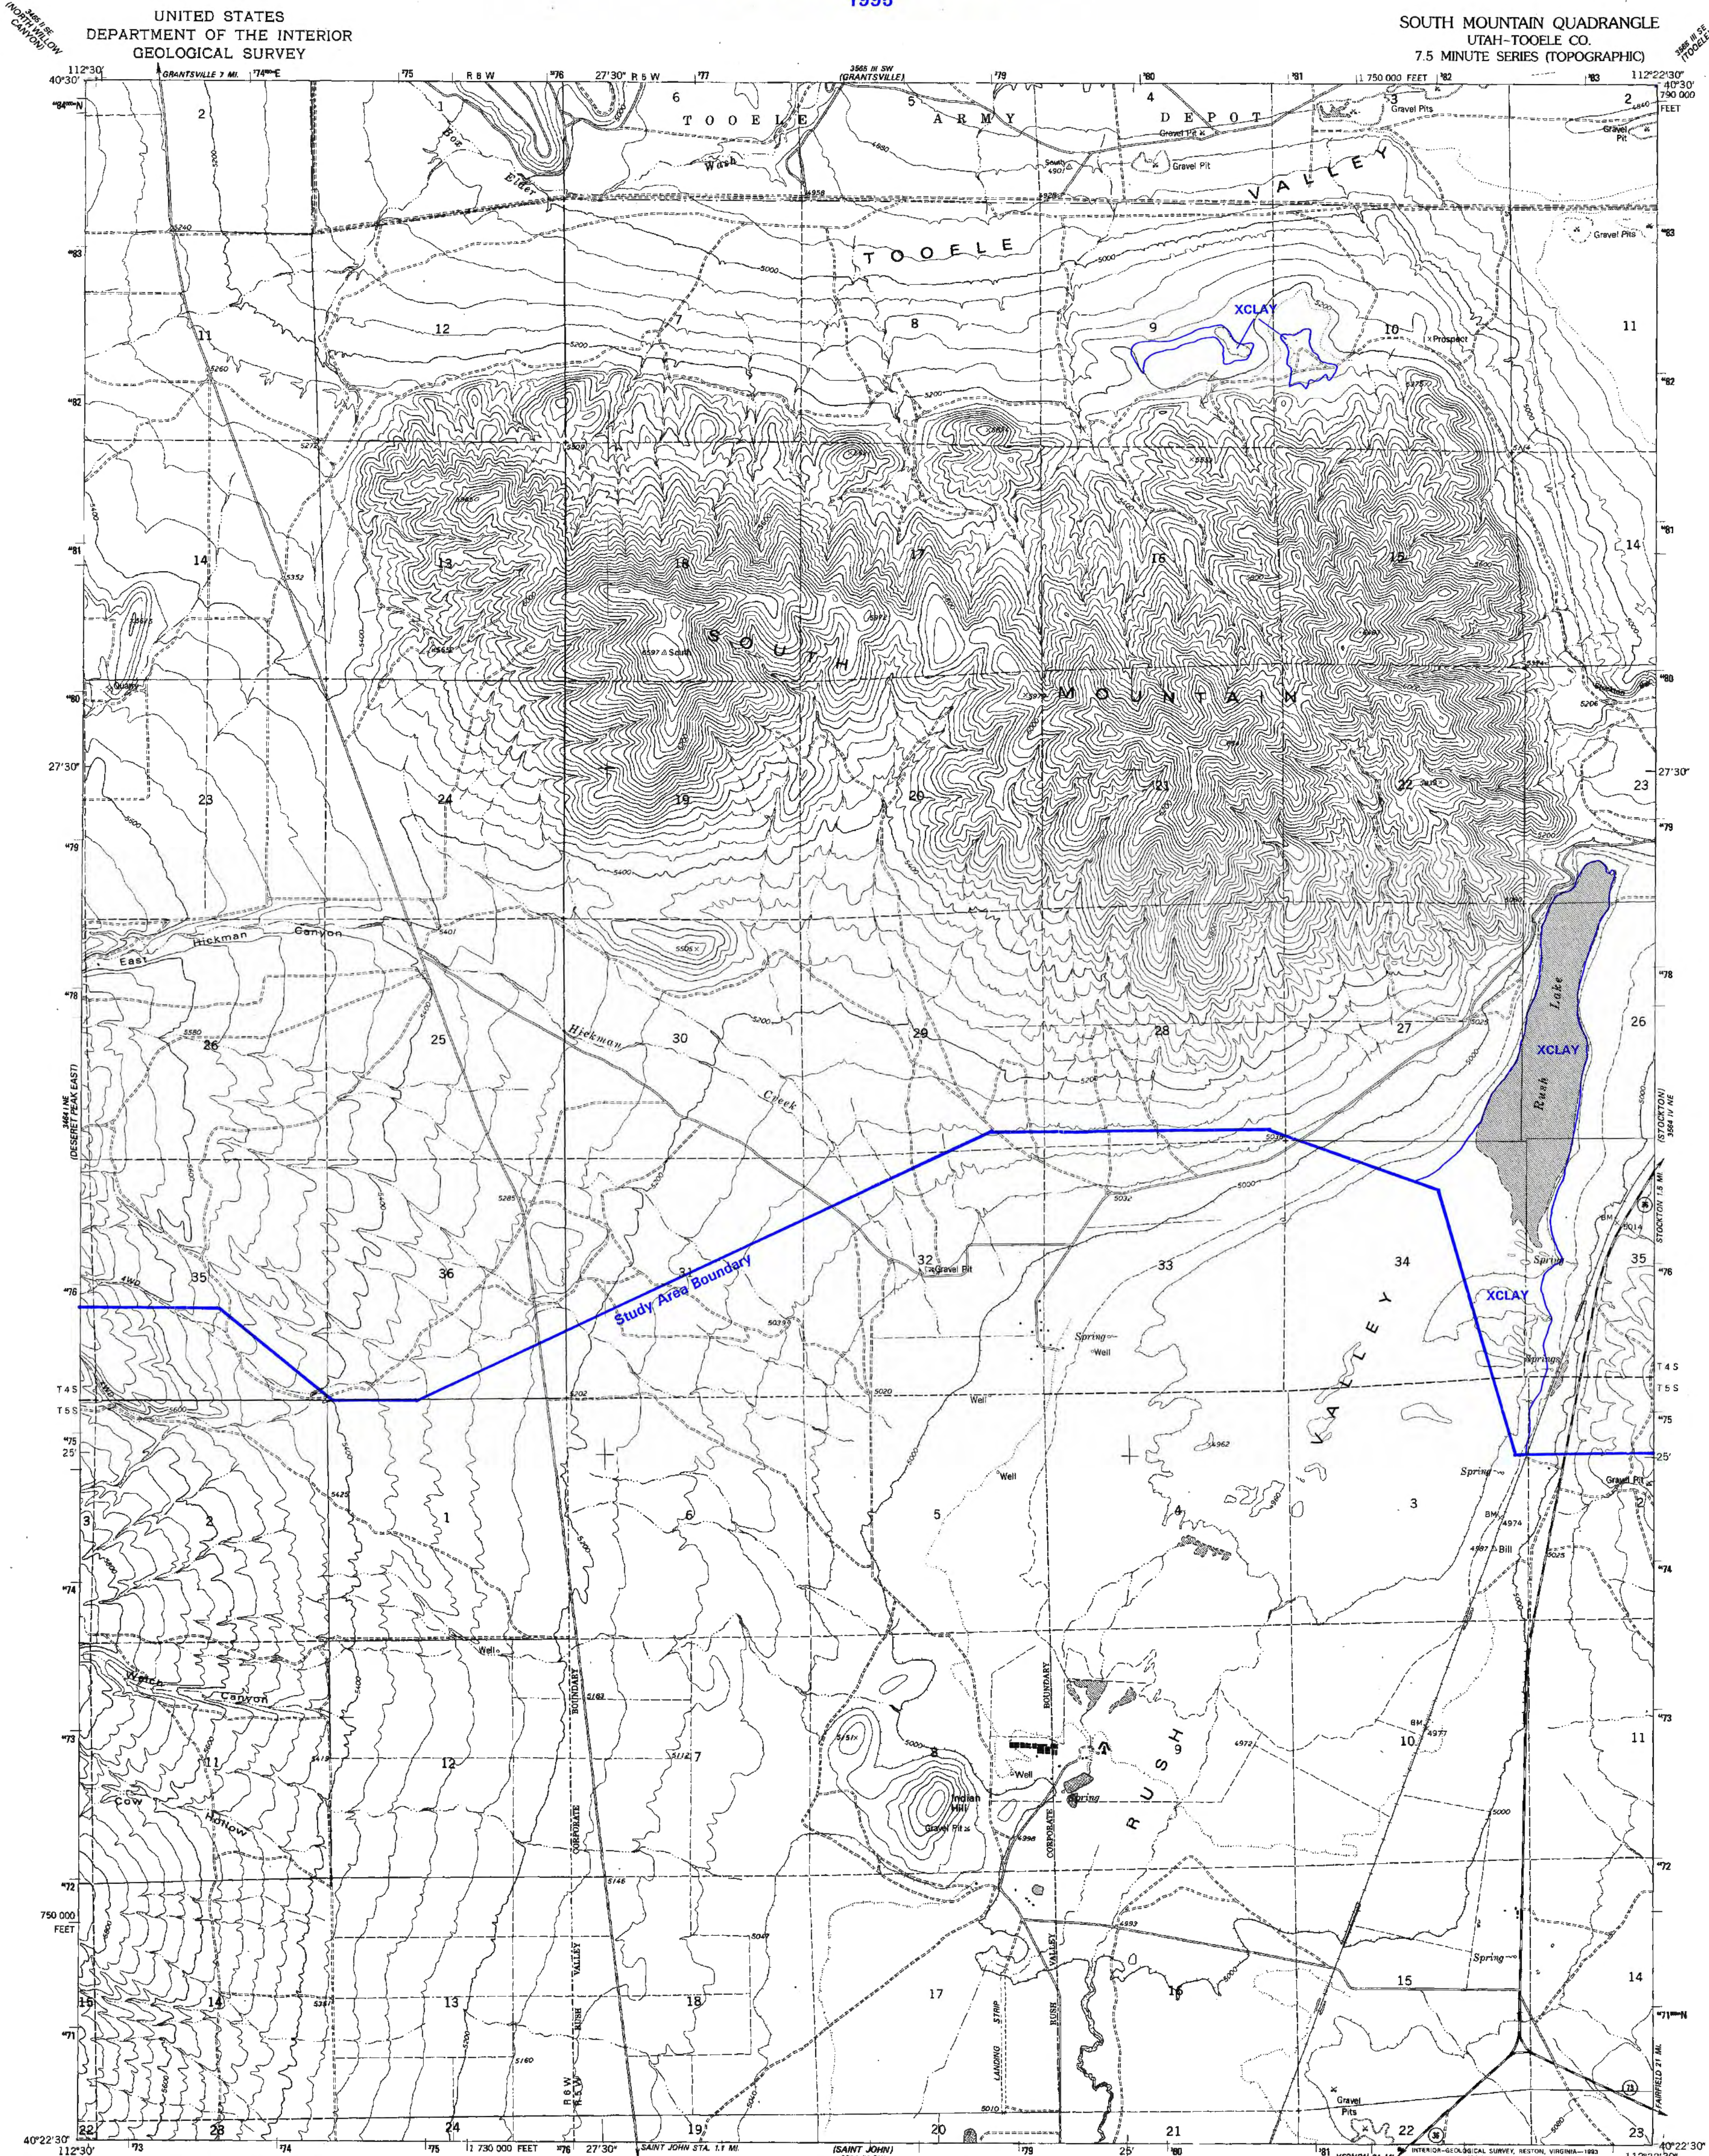
COMPILED BY BILL D. BLACK
DRAFTED BY NOAH P. SNYDER
Utah Geological Survey
Open-File Report 318 PLATE 5K
1995

Problem soils, South Mountain quadrangle, Tooele County, Utah.

XCLAY Possible expansive soil.
GYP Possible gypsiferous soil.
GYP/XCLAY Both possible gypsiferous and expansive soils.

Note: A standard soil investigation is recommended in all areas, including those
where expansive and gypsiferous soils are not present (see table 1).
