THE 2001 HEATHER DRIVE LANDSLIDE

Layton, Davis County, Utah

by Ashley Elliott

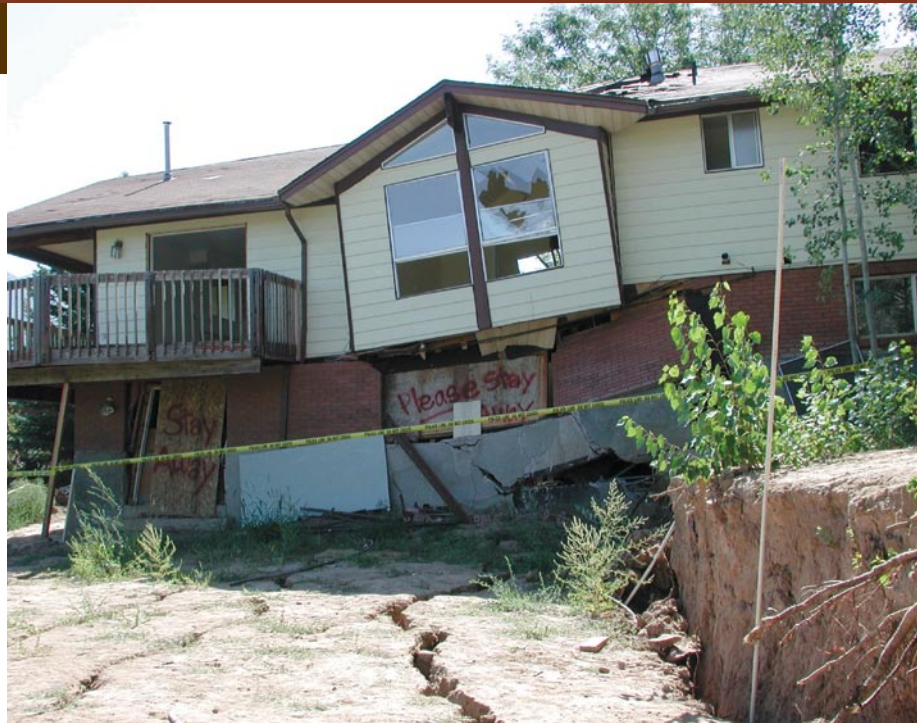
The August 2001 Heather Drive landslide in Layton damaged six houses, forcing homeowners to evacuate them. Three houses were saved and moved off the landslide, but the other three were so severely damaged they had to be demolished. Landslide movement also severed underground utility service to the houses. Estimates of homeowner equity loss, mortgage company loss, utility company costs, and Layton City costs exceed \$1 million. Unfortunately, although the landslide was identified in a 1970s geotechnical study, a detailed site investigation was not completed to determine safe locations for the houses to be built.

Top: Landslide movement severely damaged this house, which was later demolished. Bottom: Location of the 2001 Heather Drive landslide.

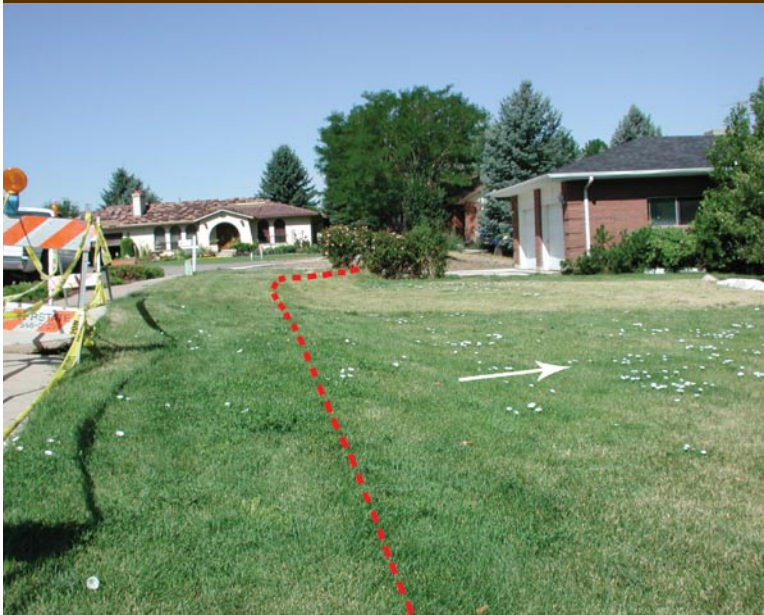
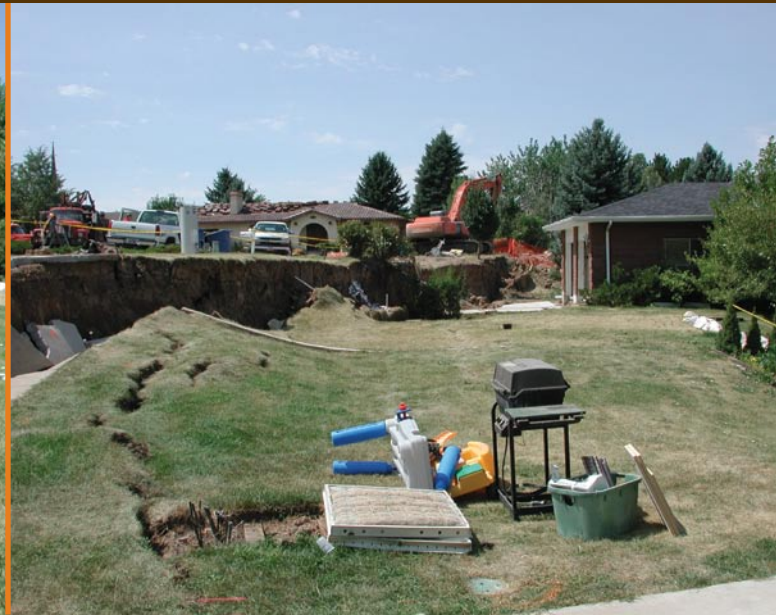
The progression of landslide movement: Photo at left shows a slight roll in the grass (indicated by the dashed red line) on August 8, 2001, that became the head of the landslide. White arrow indicates direction of movement. Photo at right shows the head of the landslide on August 27, 2001, and the ground displacement produced by 19 days of movement.

The cause of the 2001 Heather Drive landslide movement is unclear. Other nearby landslides reactivated in 1998 as the result of above-normal precipitation and elevated ground-water levels.

However, the Heather Drive landslide occurred during a dry year,

and most of the movement took place in late August. This late-summer movement is unusual, as most landslide movement that occurs in northern Utah typically does so in the spring. However, homeowners did notice some slide movement as early as 1997 or 1998.

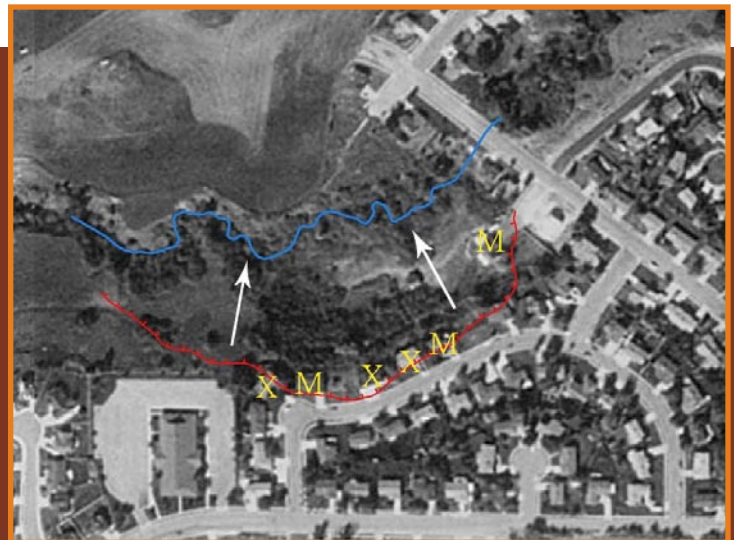
Aerial photo of the Heather Drive area prior to landslide movement. Red line indicates the top of the landslide. Blue line represents South Fork Kays Creek. White arrows indicate direction of landslide movement. Yellow X indicates a house that was demolished. Yellow M indicates a house that was moved off the landslide.
