SURVEY NOTES

UTAH GEOLOGICAL AND MINERAL SURVEY

GEOLOGIC HAZARDS AND LAND-USE PLANNING, WASATCH FRONT

GEOLOGIC HAZARDS ORDINANCES AND THE COUNTY HAZARDS GEOLOGIST PROGRAM

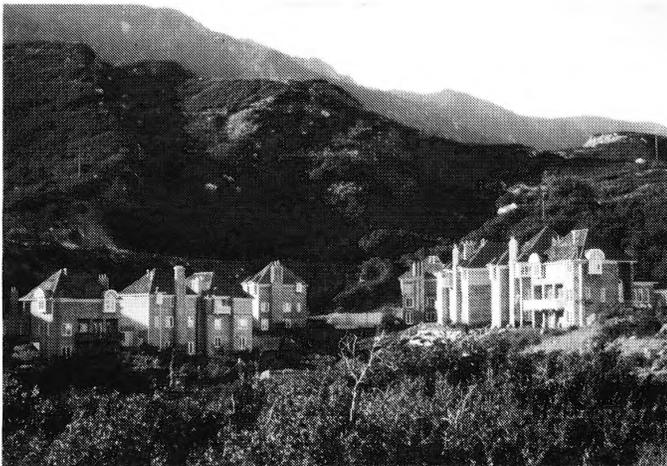
FIGURE 1. Scarps along the Wasatch fault in glacial moraines at the mouth of Little Cottonwood Canyon, Salt Lake County.

Earthquakes are generated by ruptures along faults, and during large, deep-focus earthquakes the ruptures may propagate to the surface to form scarps. Evidence for large prehistoric earthquakes along the Wasatch Front is apparent from the numerous well-developed scarps along the Wasatch and other faults in the area (figure 1). The long-term recurrence estimate

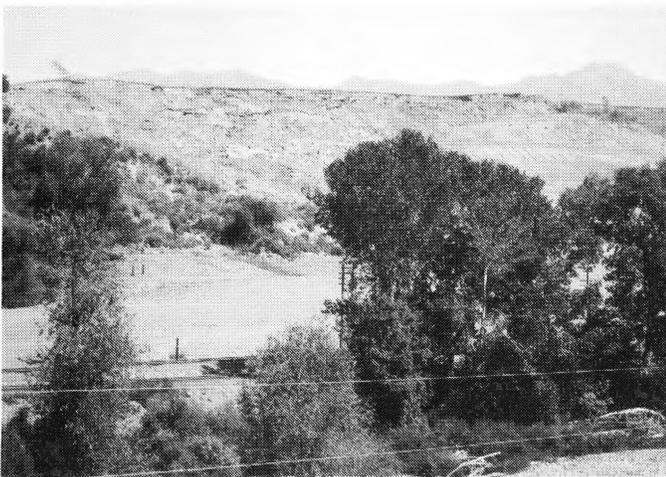
FIGURE 2. "Railroad" landslide in 1981 in the Washington Terrace landslide complex along the Weber River.

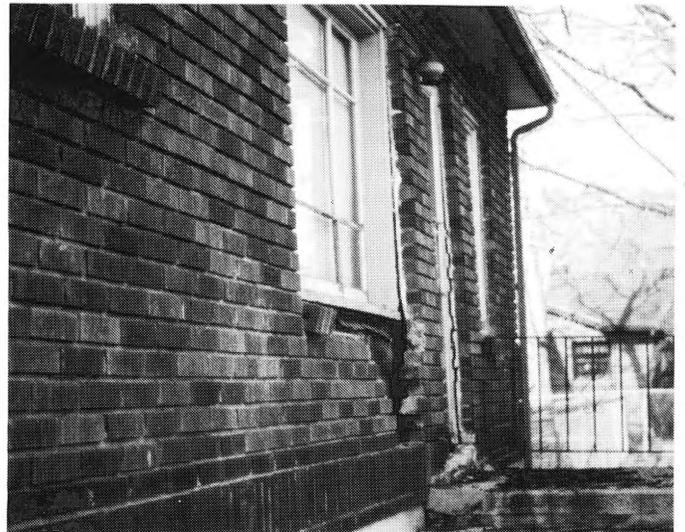
FIGURE 3. Damaged house on the toe of the 1983 South Weber Drive landslide in Riverdale.

The bluff on the south side of the Weber River is known as the South Weber landslide complex. In February 1983, seven houses which had been built on an old landslide just north of the Weber/Davis County line in Riverdale were damaged when renewed movement on the landslide occurred. One of the houses (figure 3) which was heavily damaged had been on the toe of the landslide for about 40 years before the 1983 event occurred. Old landslides may remain stable for long periods of time, but generally are highly susceptible to future landsliding, particularly if disturbed by man. The Weber-Davis Canal is frequently damaged by landslides occurring along steep slopes in the South Weber landslide complex.

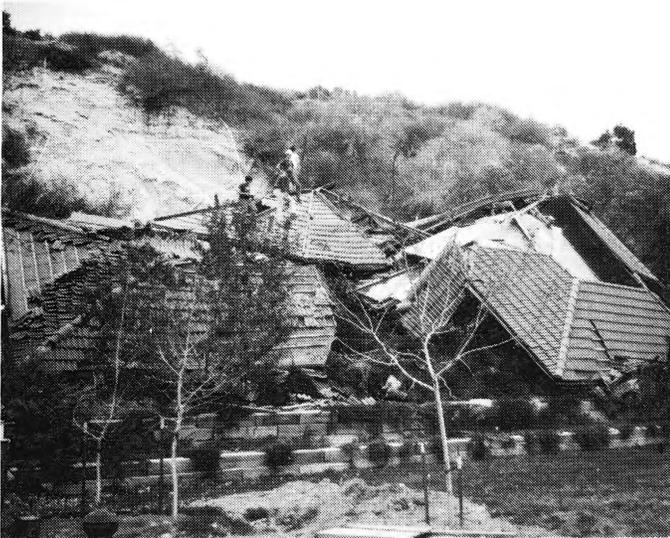
FIGURE 4. Home destroyed by a landslide in 1984 along Little Cottonwood Creek in Sandy.

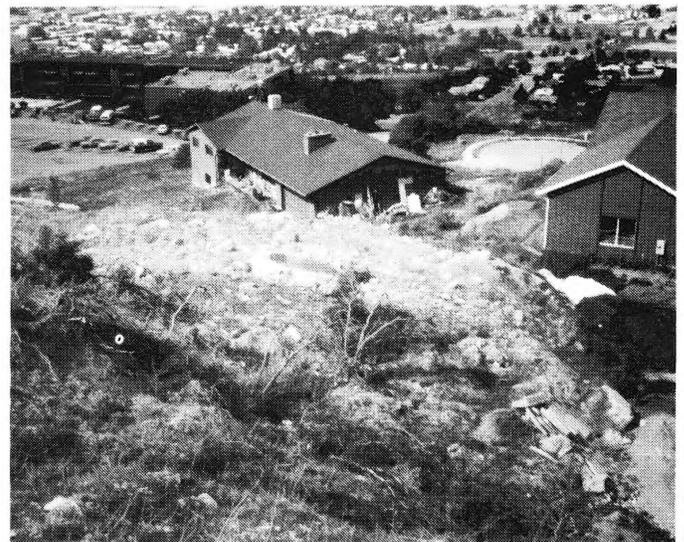
FIGURE 6. Landslide which blocked 15th East Street and threatened homes in 1983 in Provo.

bench of Provo City has been particularly affected. Renewed movement in 1983 in part of a prehistoric landslide buried 15th East Street and threatened neighboring homes (figure 6). In the Sherwood Hills area of north Provo, landslides have damaged homes and roads as the underlying Manning Canyon Shale has failed. Smaller landslides are found in bluffs along rivers and are a particular problem in cut slopes, but have not been as extensive as in Weber and Davis Counties.

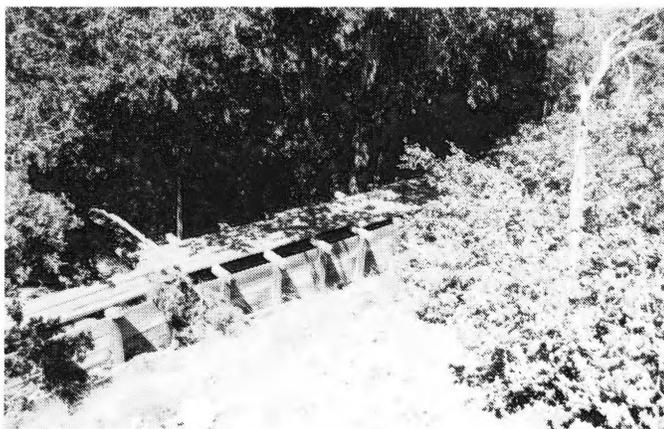
Tree split by rockfall clast. Trunk diameter is approximately 4 inches (10 cm). Broken piece is resting on flume near the rockfall clast which damaged the flume on the downslope side.

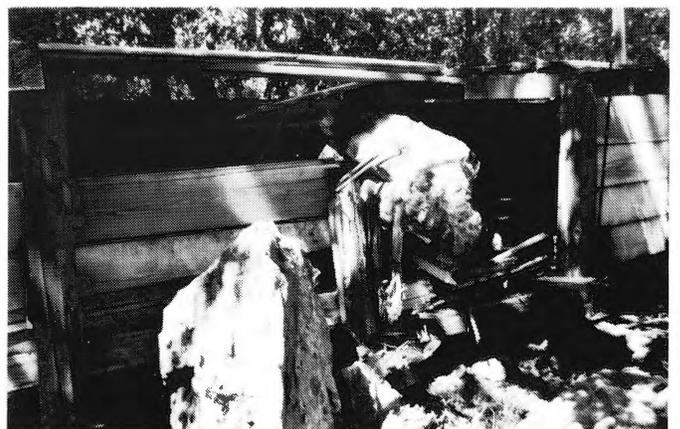
Rockfall clast which broke on impact with the upslope side of the wooden flume. The maximum diameter of the clast before impact with the 8 x 8-inch (20 x 20-cm) beam was approximately 6 feet (2 m).

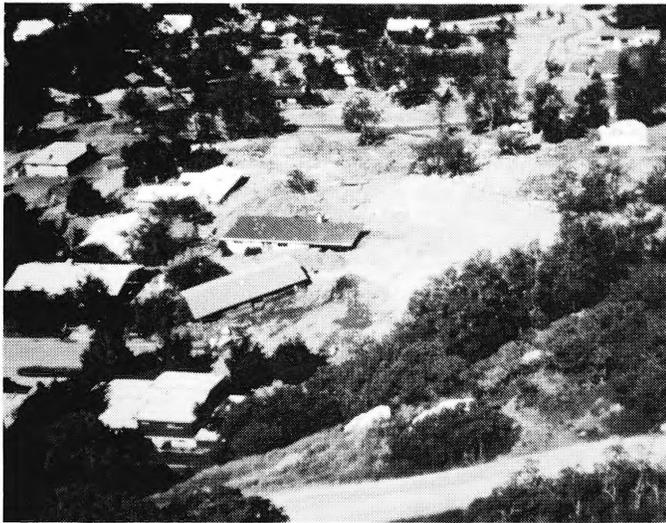
FIGURE 7. Debris flow at the mouth of Rudd Canyon in Farmington in 1983.

Debris flows present the greatest hazard when they reach canyon mouths in developed areas. Such areas where this is likely to occur can be determined from the historical record and can be recognized in the geologic record by the occurrence of steep, bouldery, alluvial-fan deposits overlying Lake Bonneville materials at mountain fronts. The county geologists are compiling maps of these areas and are recommending that an analysis of the debris-flow hazard and possible mitigating measures be performed prior to development. In determining the need for such reports, the county geologists will consider the stability of hillslope materials in source areas and the presence of debris basins at canyon mouths.

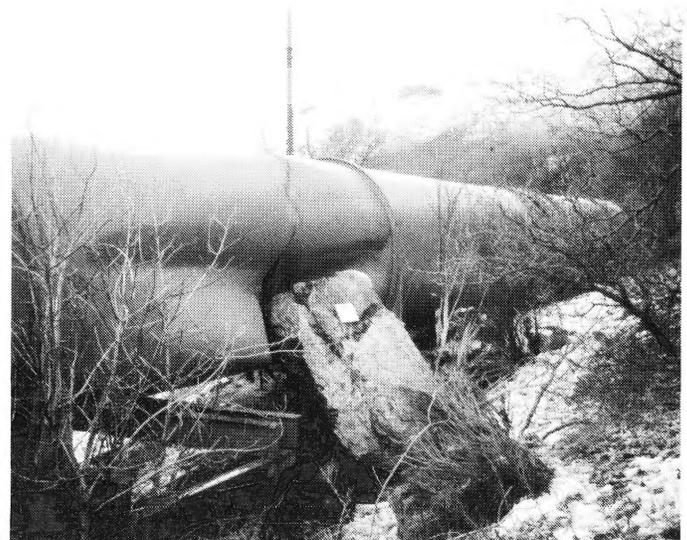
FIGURE 8. Rock-fall boulder which ruptured the Olmstead aqueduct in Provo Canyon in 1986.

Last year a rock fall from a ledge in Provo Canyon struck the Olmstead aqueduct after rolling over 1500 feet (figure 8). Water escaping from the holes in the pipe washed out the access road and contaminated Provo City's drinking-water springs below the pipe in Provo Canyon.

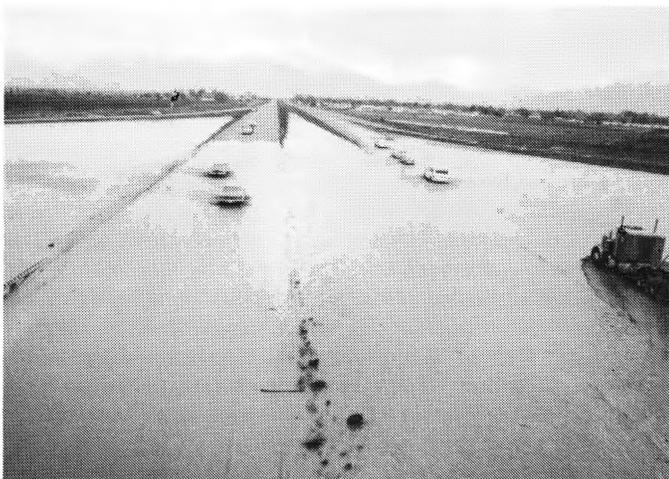
FIGURE 9. Flooding of Interstate 15 by Utah Lake in the Spanish Fork area in 1984.

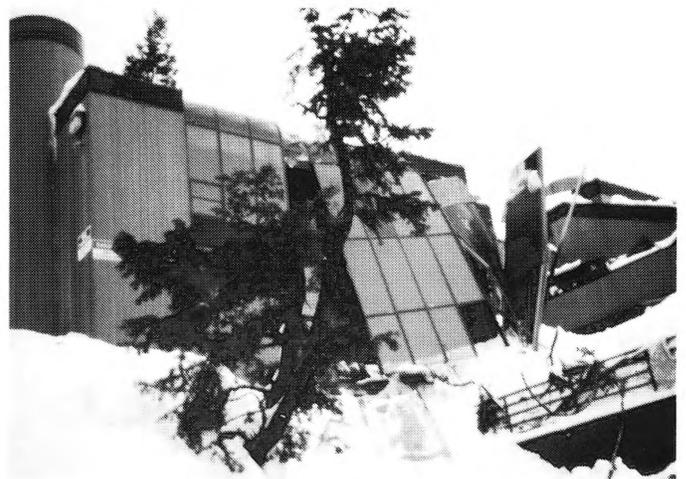
FIGURE 10. Cabin hit by avalanche near Sundance in 1986 causing over \$1.5 million in damage.

Avalanches are common occurrences in mountainous regions, and several cabins and other structures, including facilities at Bridal Veil Falls, were damaged by avalanches during the winters of 1985 and 1986 in Utah County (figure 10). As a result, the residents of the Sundance area where some of the damage occurred hired a consultant to delineate avalanche paths and hazard areas. Avalanche hazards exist in all of the steep-walled canyons east of the Wasatch Front and must be considered in all construction in such areas. No avalanche hazard maps are being prepared by the county geologists; however, site-specific studies for all canyon development will be recommended.
